Manhole Inspection Summary

Manhole # S45AA_039MH

Inspection ☐ Is Incomplete Rating: **3) Fair**

Location Address: **Washington**

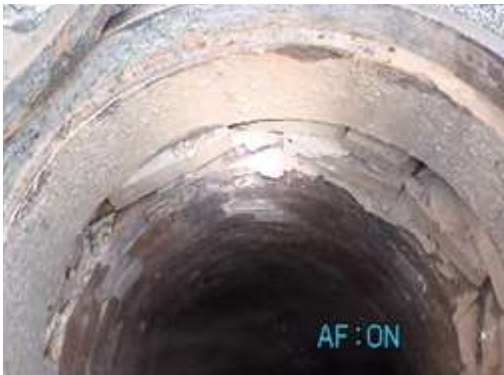
Defect 2

Condition: ☐ Sound ☐ Cracked ☐ Root Intrusion ☒ **Loose Brick** ☐ Deteriorated

Infiltration: ☐ None ☐ Joint ☐ Cracks ☒ **Mortar** ☐ Roots ☐ Wall

Loose bricks

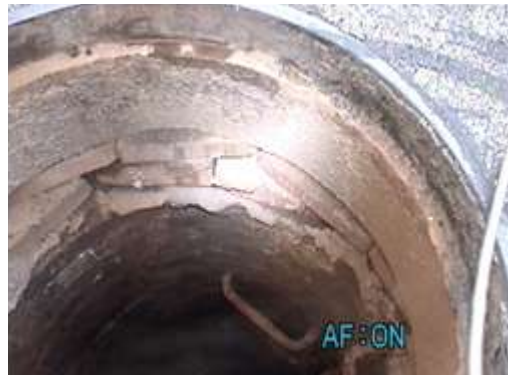
Defect 1

Frame leaks

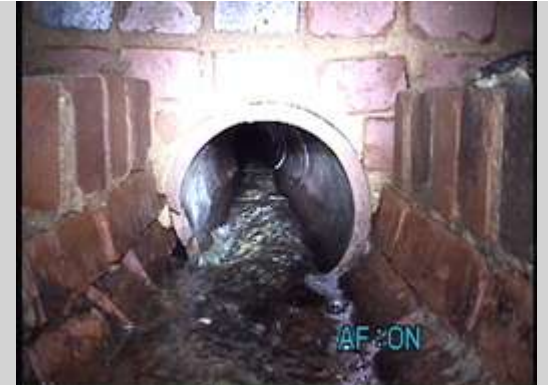
12 O'Clock Outflow

8 in. Circular Gravity Sewer
Pipe Out @ 12 O'Clock

Pipe Height: **8.4** (in.) Rod and Bar (Angled)
Pipe Material: **Clay** ☐ Pipe Lined
Invert Depth: **11.25** (ft.) Flow Characteristics: **Fast**
Deposits: ☒ None ☐ Mud ☐ Sludge ☐ Debris ☐ Grease
Silt Depth: (in.) Deposits Extent:
Infiltration: **None** Pipe Seal Cond: **Broken**

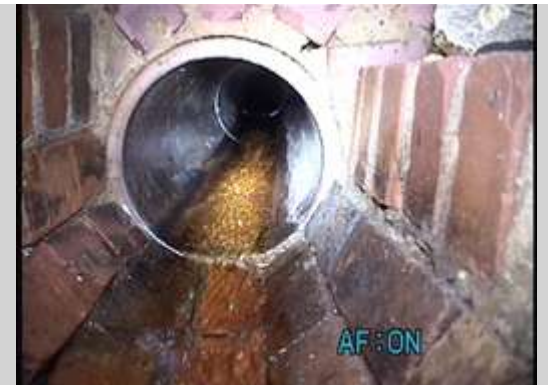
6 O'Clock Inflow

8 in. Circular Gravity Sewer
Pipe In @ 6 O'Clock

Pipe Height: **8.4** (in.) Rod and Bar (Angled)
Pipe Material: **Clay** ☐ Pipe Lined
Invert Depth: **11.20** (ft.) Flow Characteristics: **Fast**
Deposits: ☒ None ☐ Mud ☐ Sludge ☐ Debris ☐ Grease
Silt Depth: (in.) Deposits Extent:
Infiltration: **None** Pipe Seal Cond: **Sound**

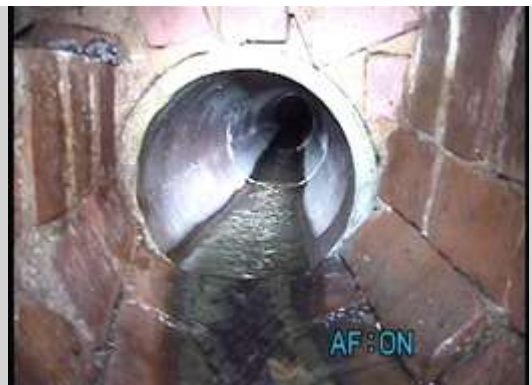
9 O'Clock Inflow

Pipe In @ 9 O'Clock

Infiltration: **None**

Pipe Seal Cond: **Sound**
